Infrared Inspection Report Roof System

Jefferson County Jail

Report Date: February 26, 2021

Job Number: 20210210JCBCC

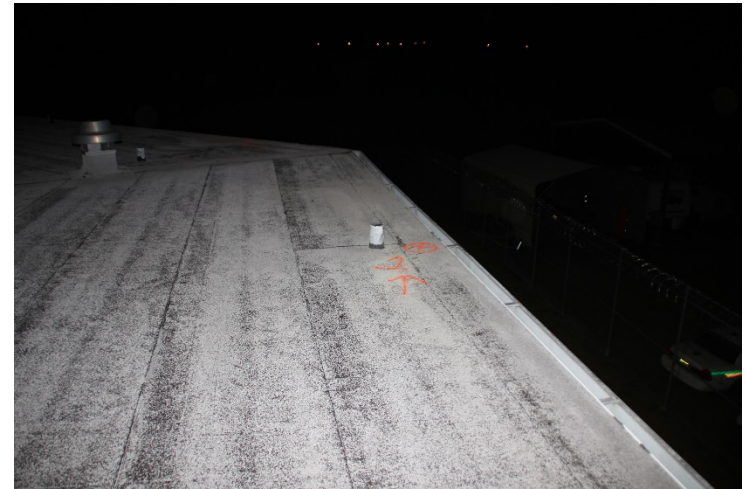
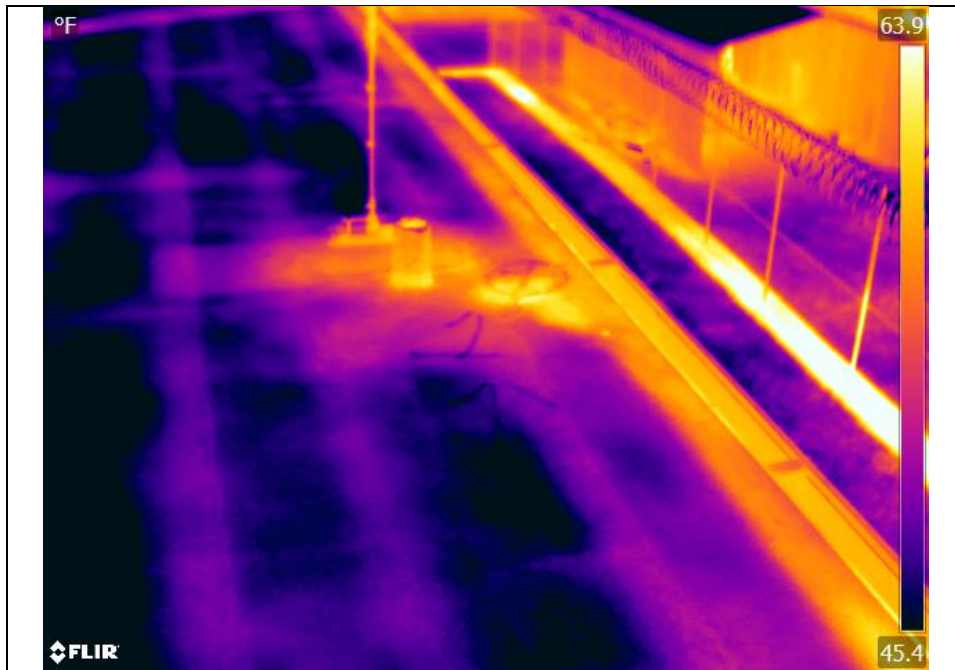
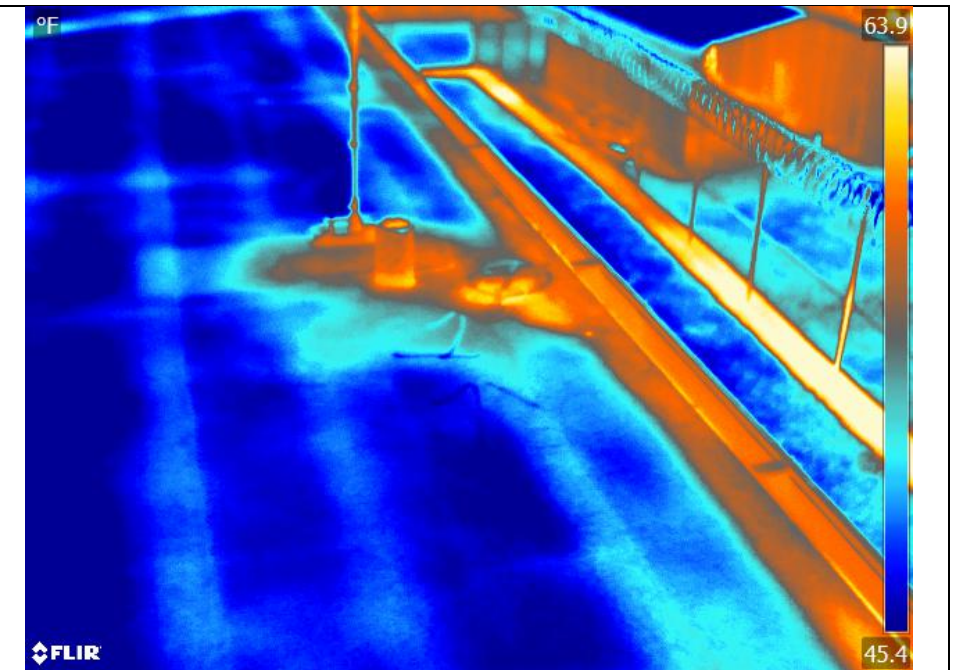
No. 1.	Job No. 20210210JCBCC	Date: 02/24/2021	Image Times: 7:50 PM – 9:18 PM
Location: Main Roof	Ambient Temp: 58 °F	Damage Type: Suspect Moisture	
Area Description:		Moisture Test Results: N/A	
Overall Size:	N/A	Moisture Probe	N/A
Previously Patched:	N/A	Core Sample:	N/A
Blisters Present:	No	Other:	Moisture Meter Positive
Comments:

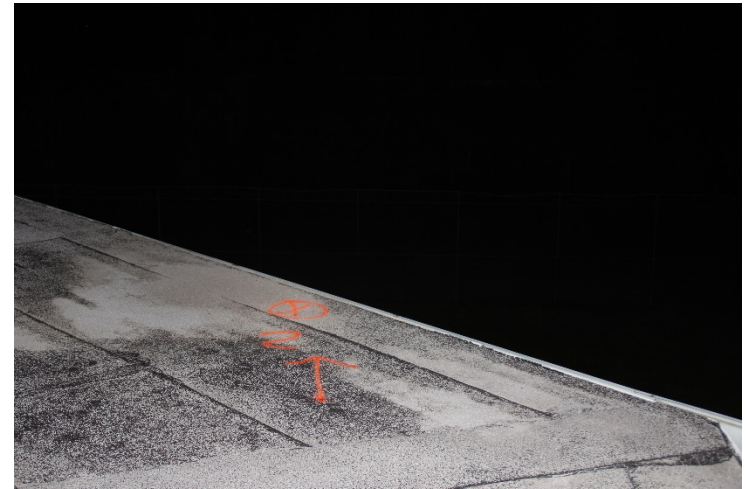
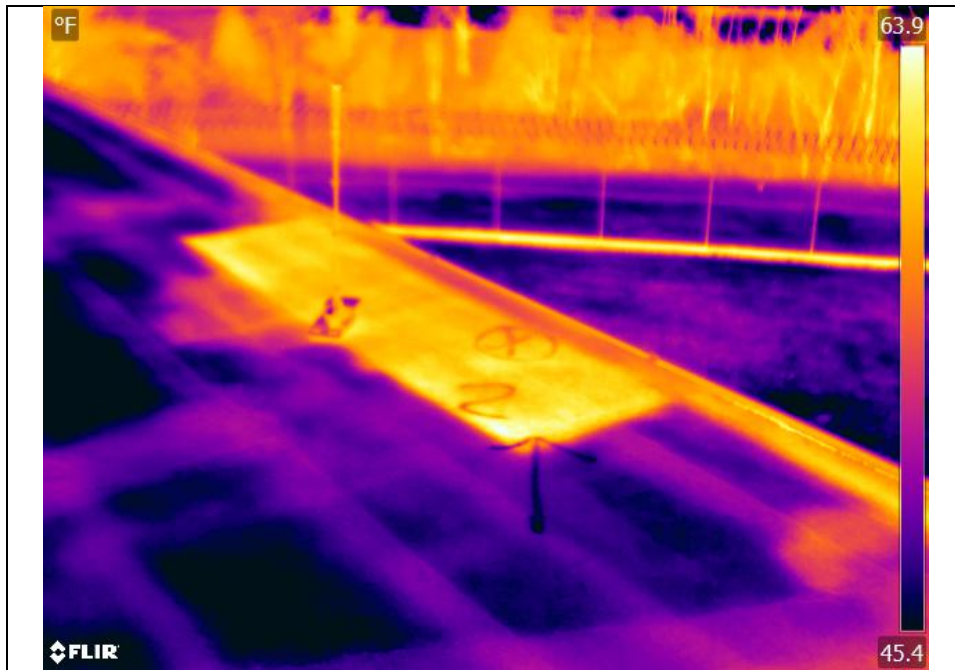
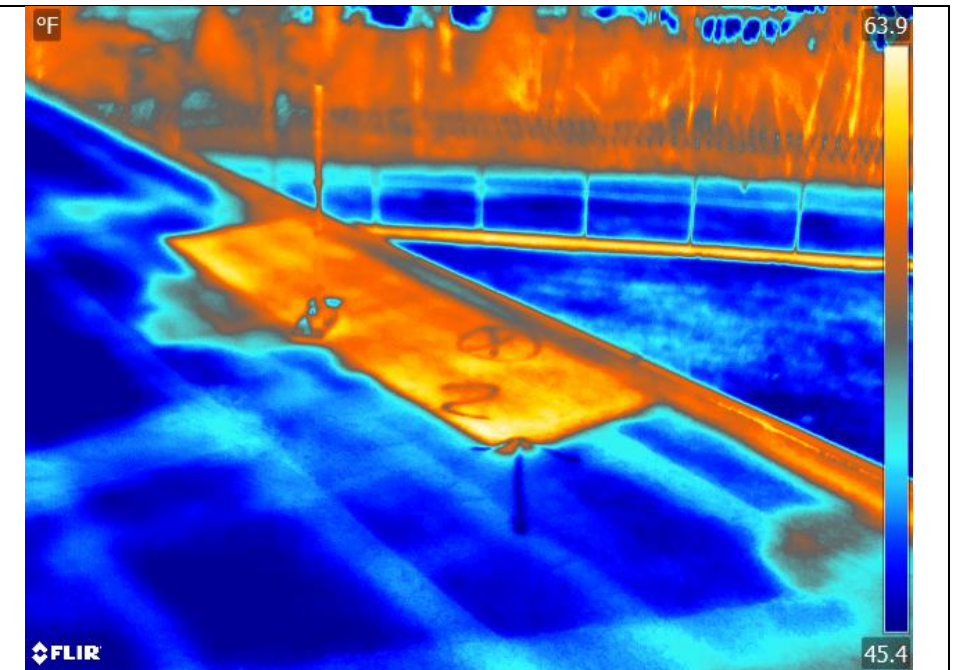
No. 2.	Job No. 20210210JCBCC	Date: 02/24/2021	Image Times: 7:50 PM – 9:18 PM
Location: Main Roof	Ambient Temp: 58 °F	Damage Type: Suspect Moisture	
Area Description:		Moisture Test Results: N/A	
Overall Size:	N/A	Moisture Probe	N/A
Previously Patched:	N/A	Core Sample:	N/A
Blisters Present:	No	Other:	Moisture Meter Positive
Comments:

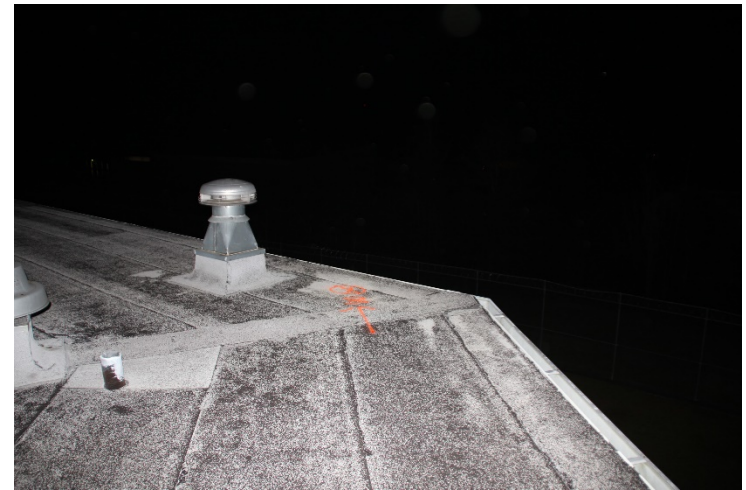
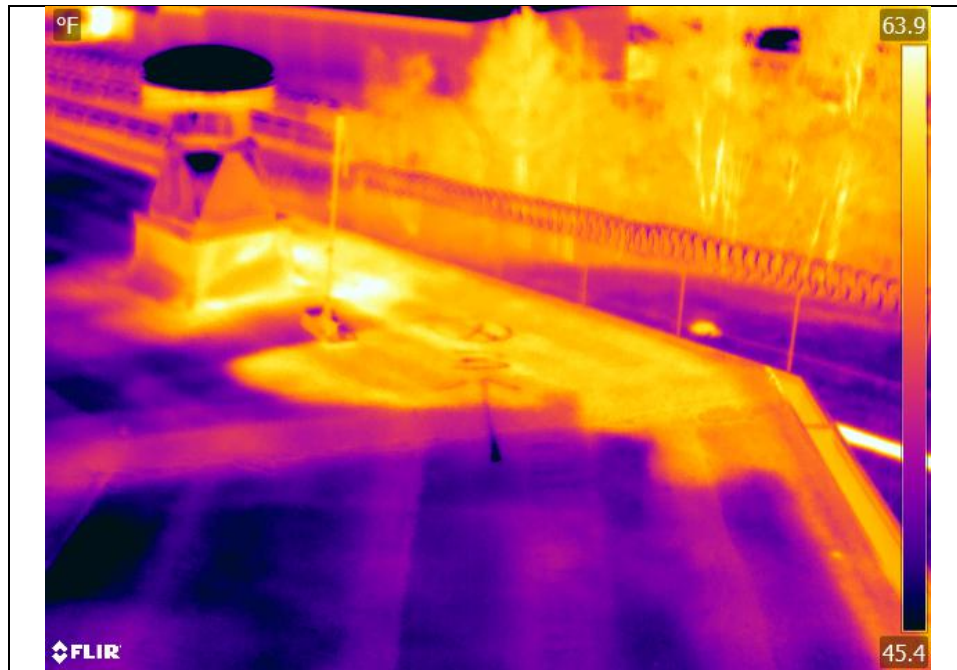
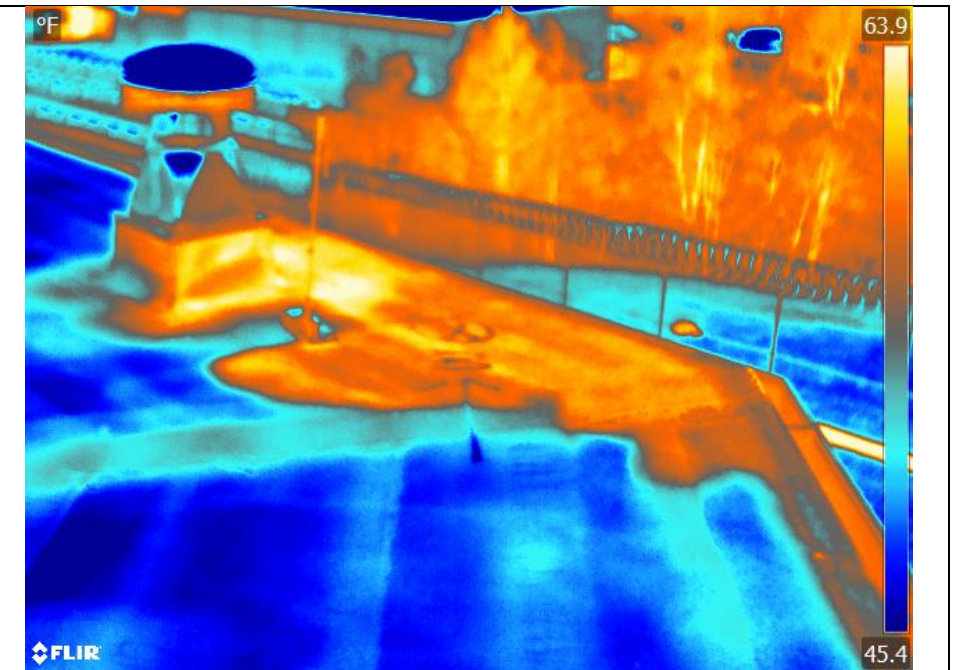
No. 3.	Job No. 20210210JCBCC	Date: 02/24/2021	Image Times: 7:50 PM – 9:18 PM
Location: Main Roof	Ambient Temp: 58 °F	Damage Type: Suspect Moisture	
Area Description:		Moisture Test Results: 23.1 - RED	
Overall Size:	N/A	Moisture Probe	N/A
Previously Patched:	N/A	Core Sample:	N/A
Blisters Present:	No	Other:	Moisture Meter Positive
Comments:	#2 core was wet to the touch.

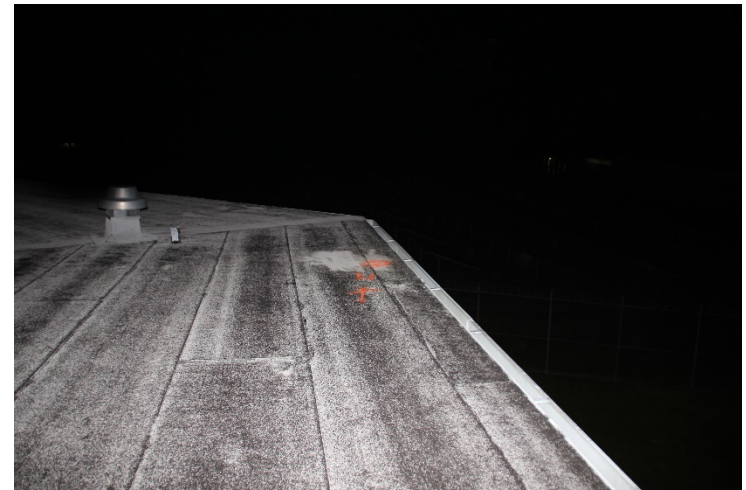
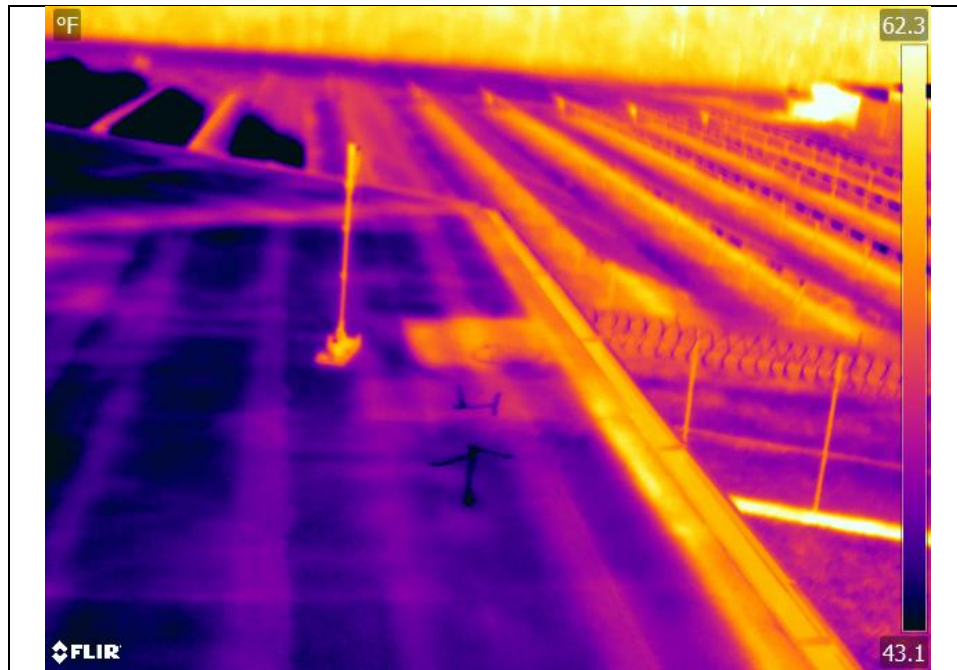
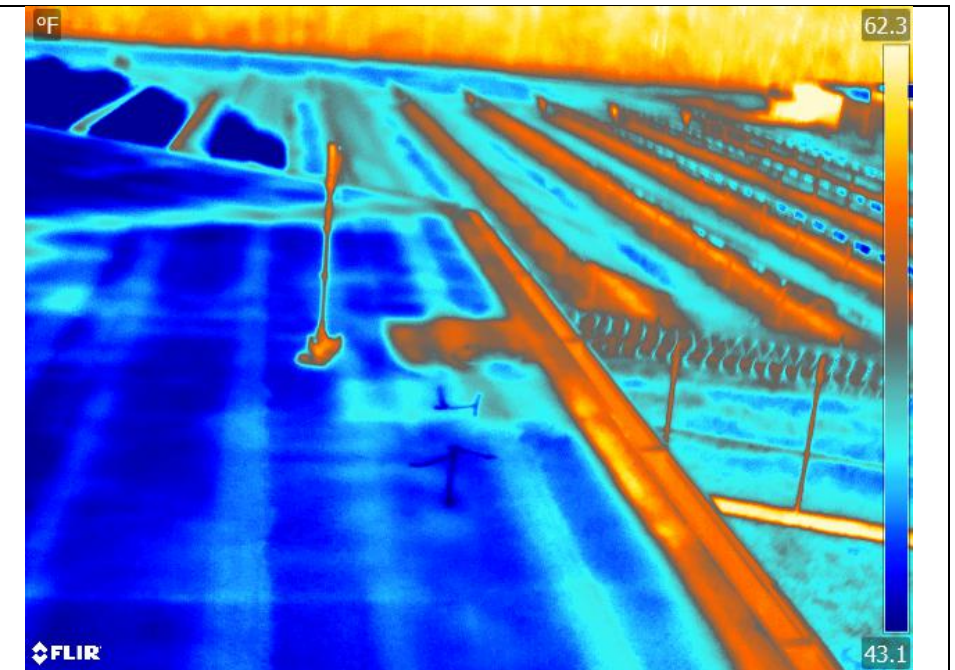
No. 4.	Job No. 20210210JCBCC	Date: 02/24/2021	Image Times: 7:50 PM – 9:18 PM
Location: Main Roof	Ambient Temp: 58 °F	Damage Type: Suspect Moisture	
Area Description:		Moisture Test Results: N/A	
Overall Size:	N/A	Moisture Probe	N/A
Previously Patched:	N/A	Core Sample:	N/A
Blisters Present:	No	Other:	Moisture Meter Positive
Comments:

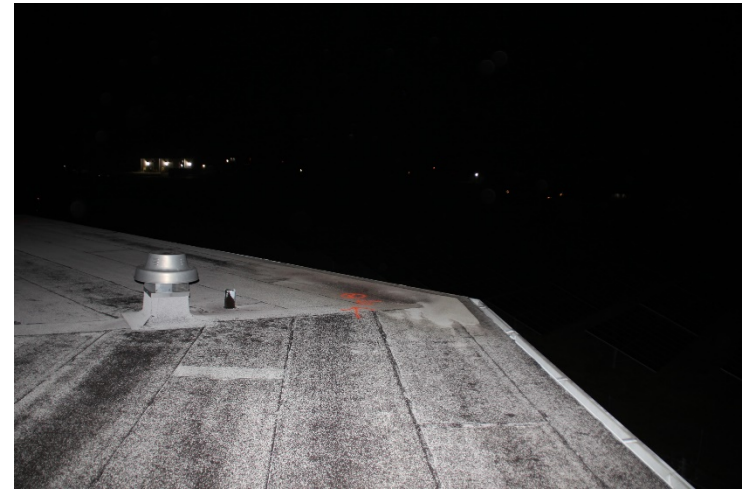
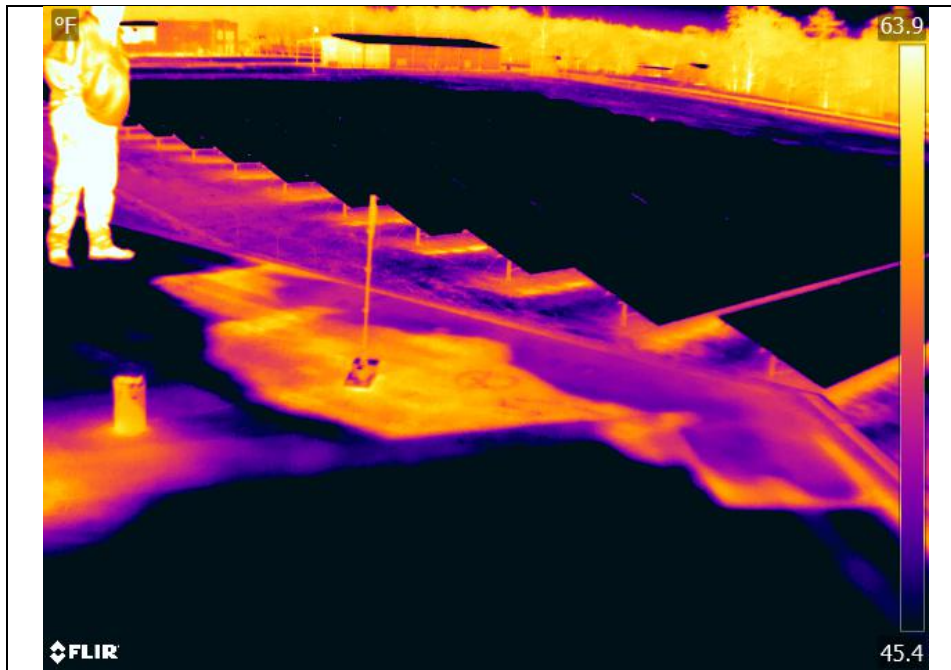
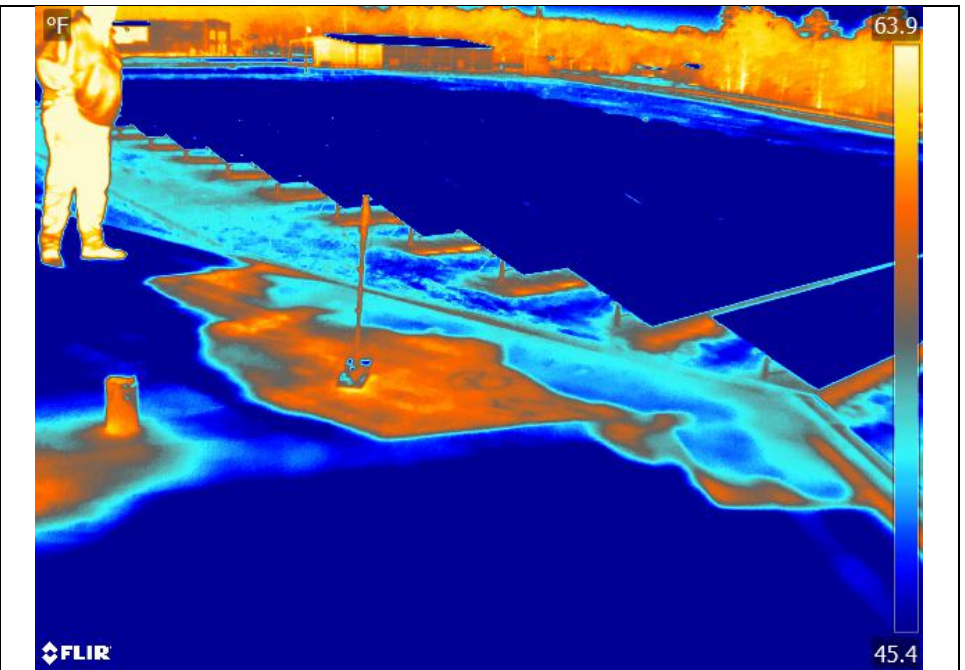
No. 5.	Job No. 20210210JCBCC	Date: 02/24/2021	Image Times: 7:50 PM – 9:18 PM
Location: Main Roof	Ambient Temp: 58 °F	Damage Type: Suspect Moisture	
Area Description:		Moisture Test Results: N/A	
Overall Size:	N/A	Moisture Probe	N/A
Previously Patched:	N/A	Core Sample:	N/A
Blisters Present:	No	Other:	Moisture Meter Positive
Comments:

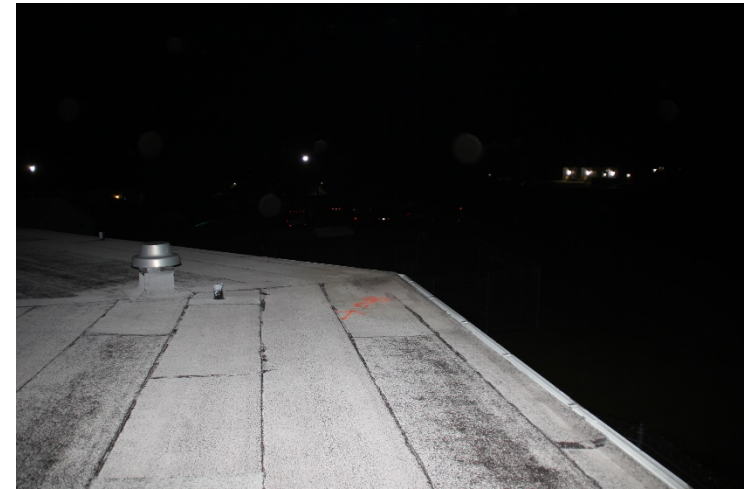
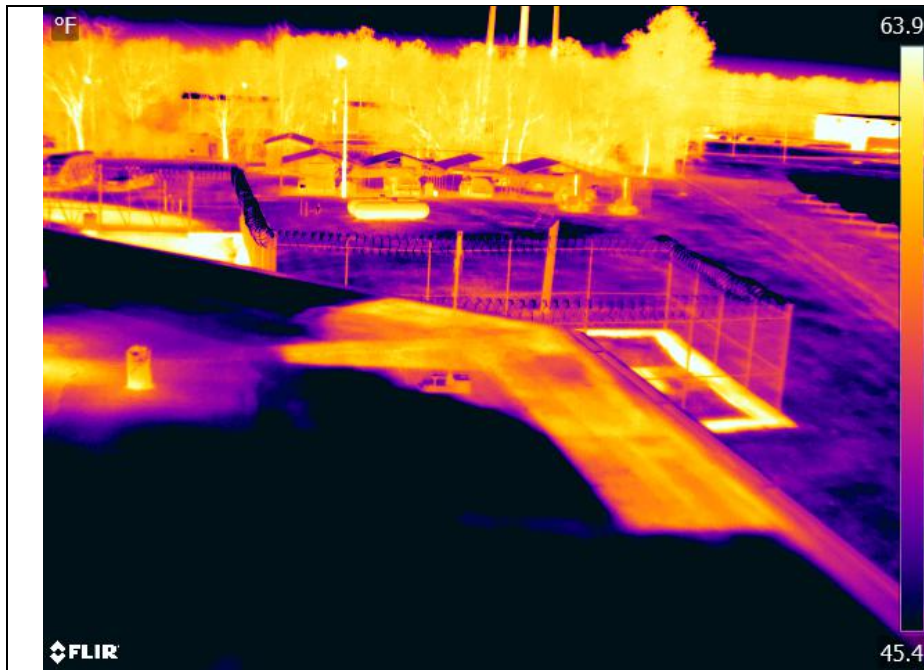
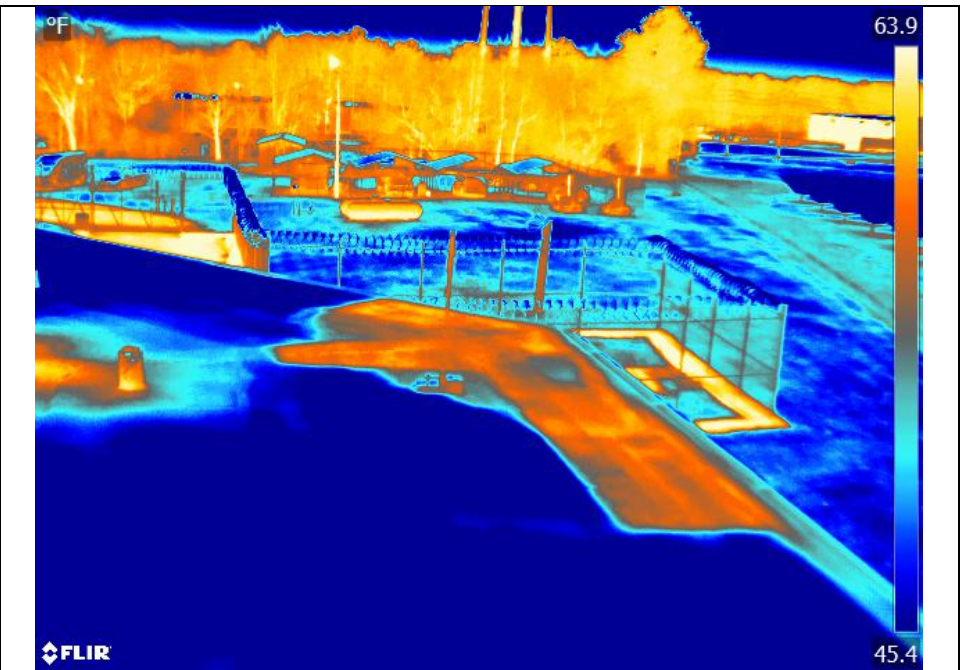
No. 6.	Job No. 20210210JCBCC	Date: 02/24/2021	Image Times: 7:50 PM – 9:18 PM
Location: Main Roof	Ambient Temp: 58 °F	Damage Type: Suspect Moisture	
Area Description:		Moisture Test Results: 40 - RED	
Overall Size:	N/A	Moisture Probe	N/A
Previously Patched:	N/A	Core Sample:	N/A
Blisters Present:	No	Other:	Moisture Meter Positive
Comments:	#3 core was wet to the touch.

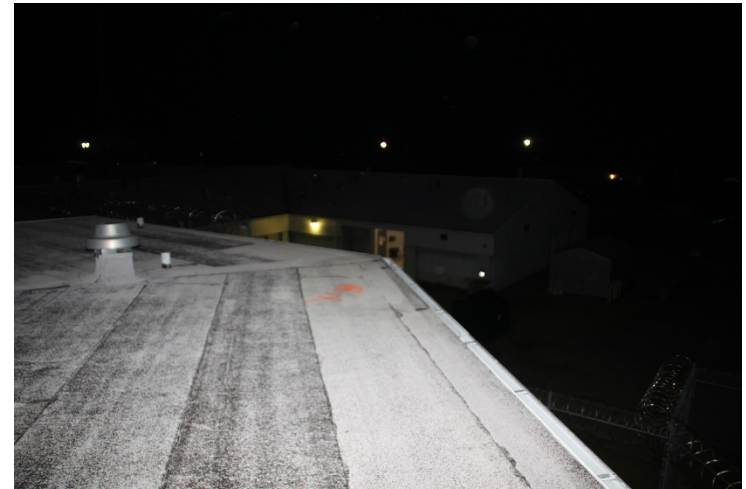
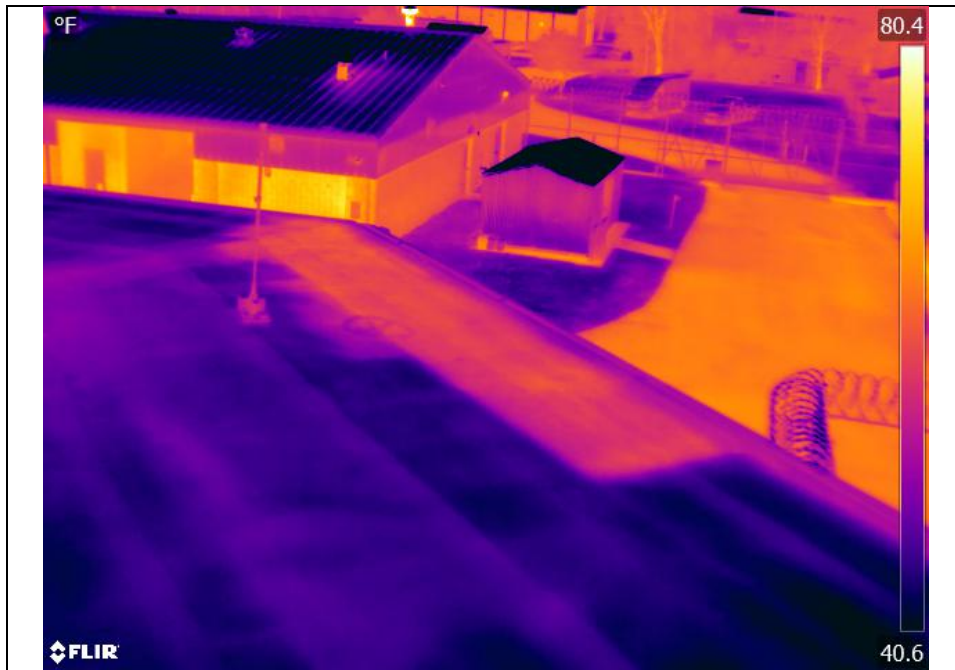
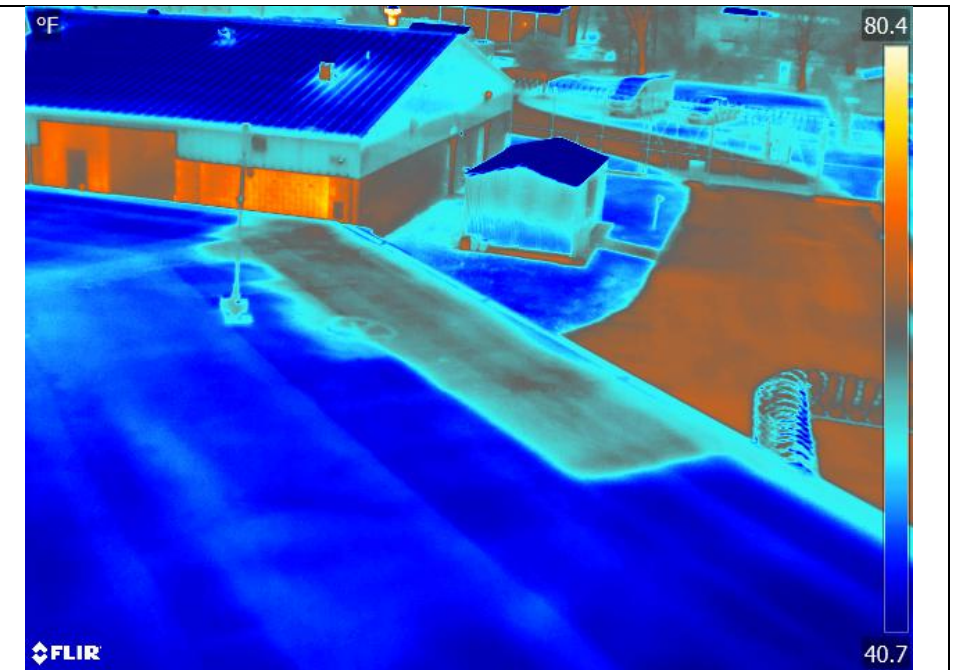
No. 7.	Job No. 20210210JCBCC	Date: 02/24/2021	Image Times: 7:50 PM – 9:18 PM
Location: Main Roof	Ambient Temp: 58 °F	Damage Type: Suspect Moisture	
Area Description:		Moisture Test Results: N/A	
Overall Size:	N/A	Moisture Probe	N/A
Previously Patched:	N/A	Core Sample:	N/A
Blisters Present:	No	Other:	Moisture Meter Positive
Comments:

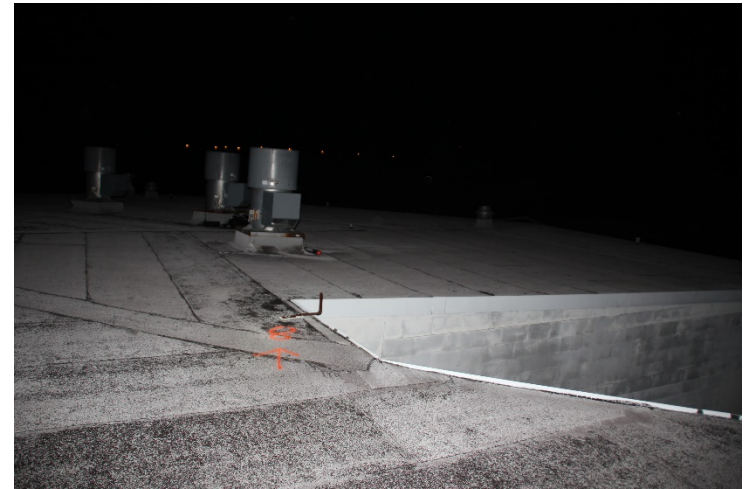
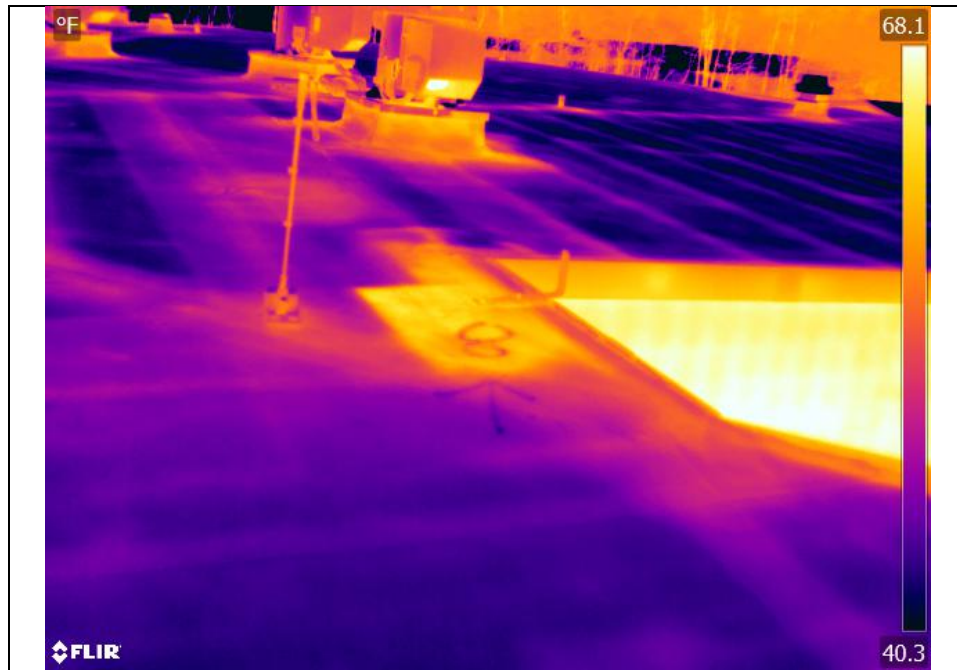
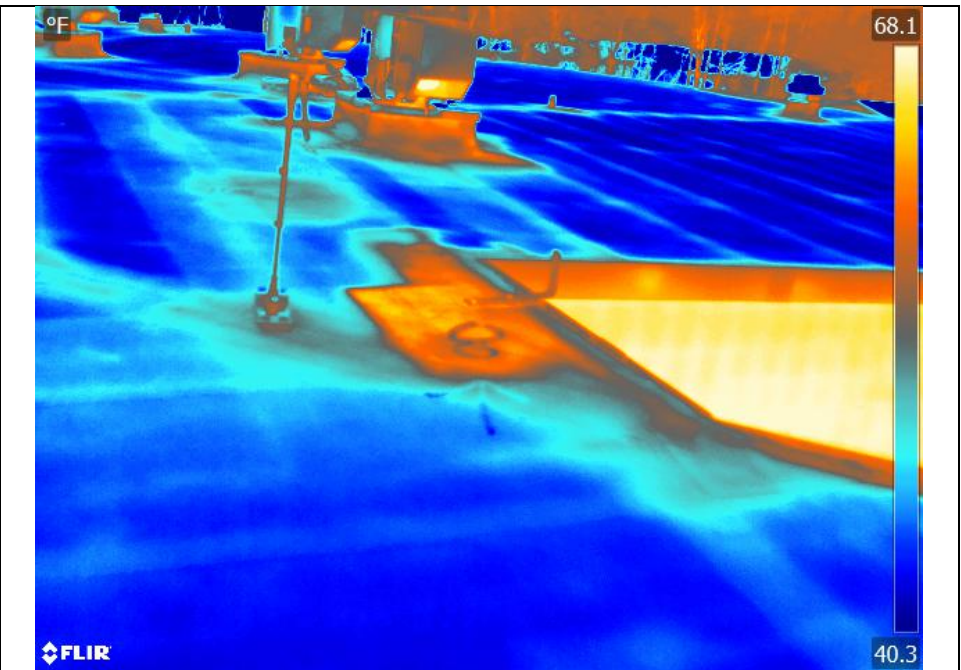
No. 8.	Job No. 20210210JCBCC	Date: 02/24/2021	Image Times: 7:50 PM – 9:18 PM
Location: Main Roof	Ambient Temp: 58 °F	Damage Type: Suspect Moisture	
Area Description:		Moisture Test Results: N/A	
Overall Size:	N/A	Moisture Probe	N/A
Previously Patched:	N/A	Core Sample:	N/A
Blisters Present:	No	Other:	Moisture Meter Positive
Comments:

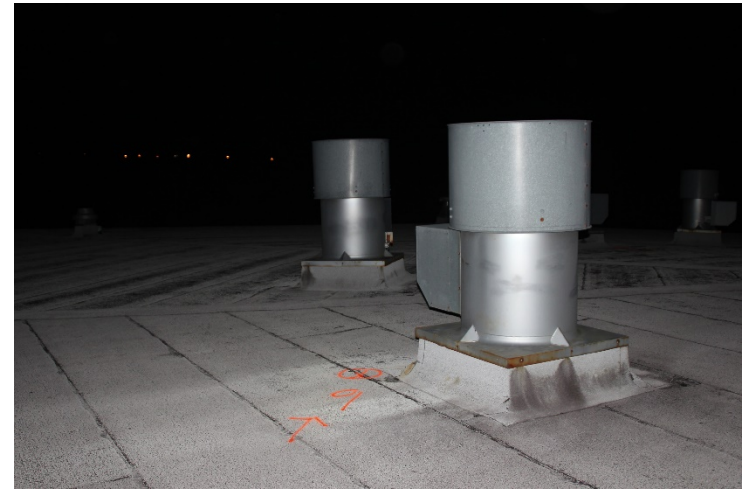
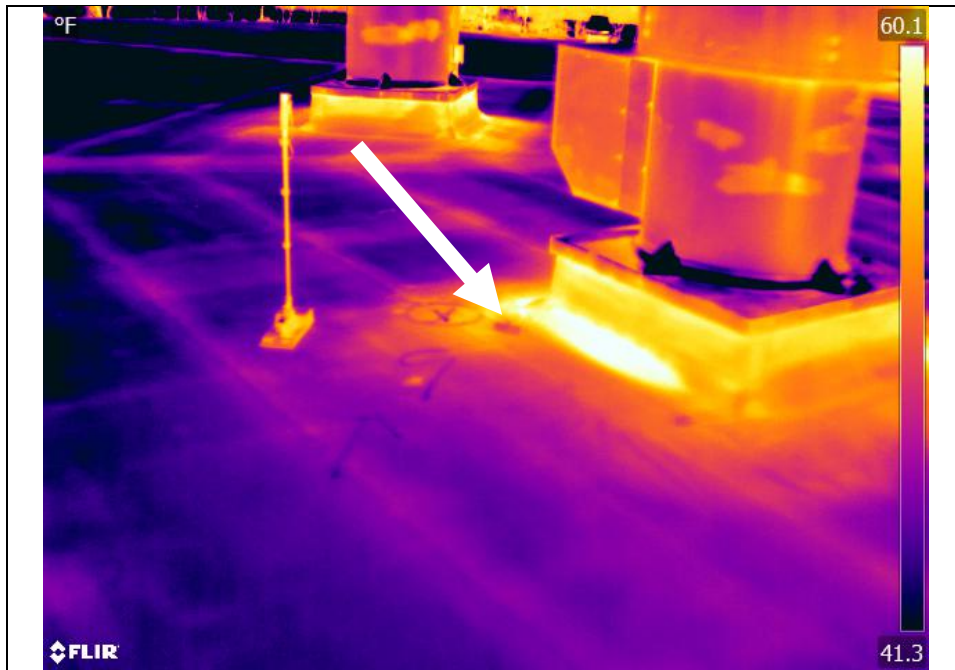
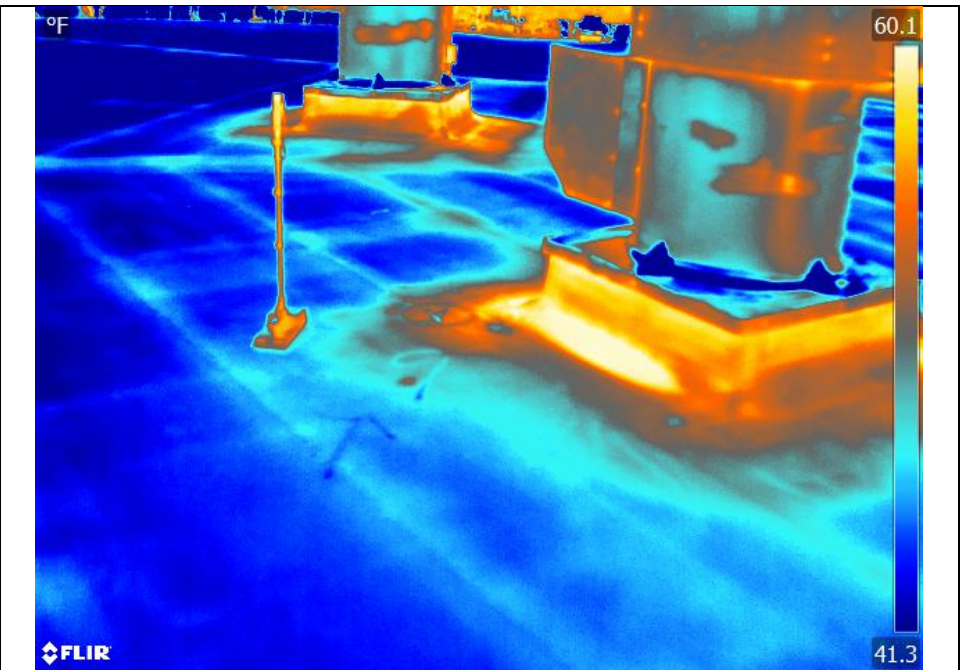
No. 9.	Job No. 20210210JCBCC	Date: 02/24/2021	Image Times: 7:50 PM – 9:18 PM
Location: Main Roof	Ambient Temp: 58 °F	Damage Type: Suspect Moisture	
Area Description:		Moisture Test Results: N/A	
Overall Size:	N/A	Moisture Probe	N/A
Previously Patched:	N/A	Core Sample:	N/A
Blisters Present:	No	Other:	Moisture Meter Positive
Comments:	The arrow denotes water leaking out of the membrane in this area.

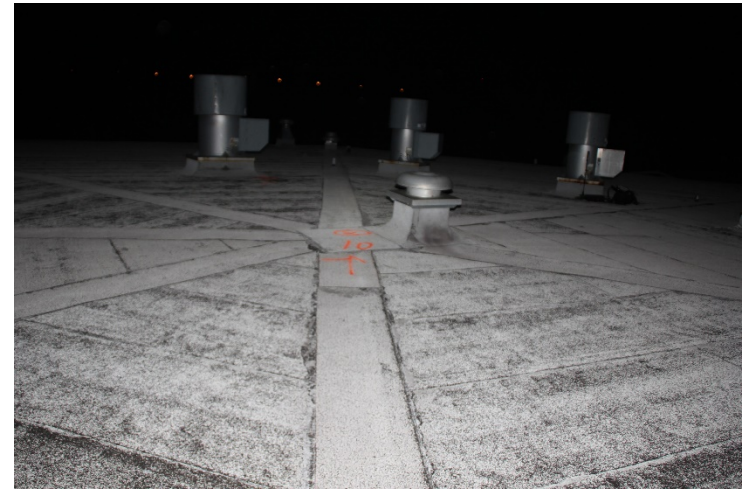
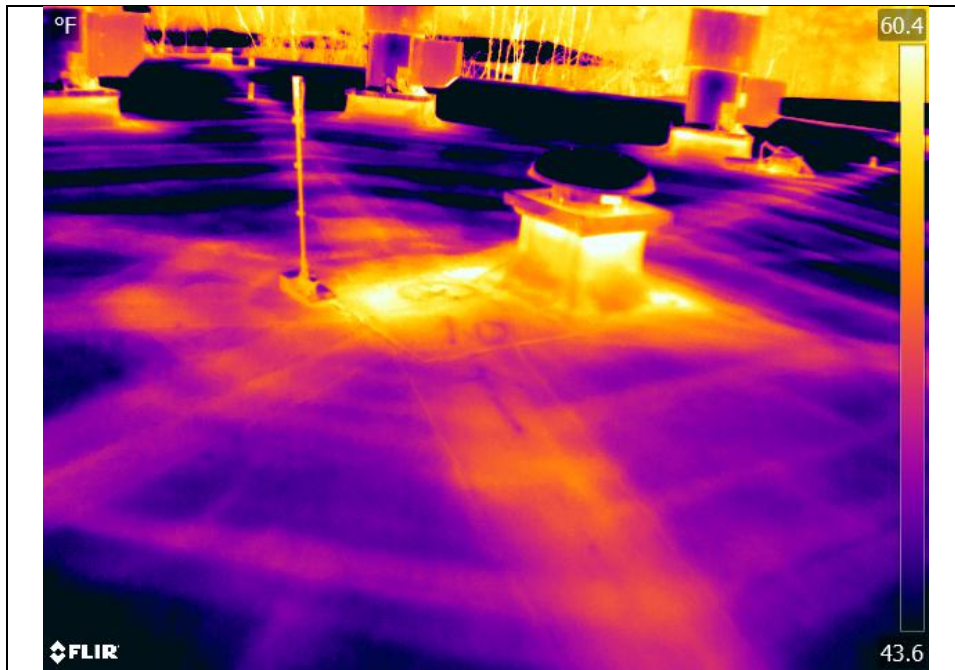
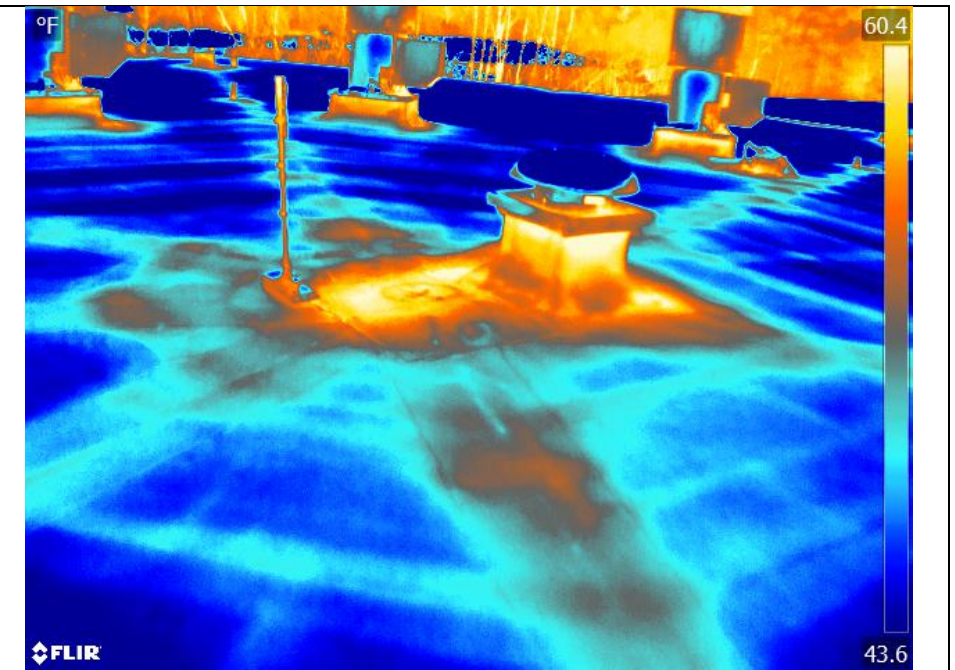
No. 10.	Job No. 20210210JCBCC	Date: 02/24/2021	Image Times: 7:50 PM – 9:18 PM
Location: Main Roof	Ambient Temp: 58 °F	Damage Type: Suspect Moisture	
Area Description:		Moisture Test Results: N/A	
Overall Size:	N/A	Moisture Probe	N/A
Previously Patched:	N/A	Core Sample:	N/A
Blisters Present:	No	Other:	Moisture Meter Positive
Comments:

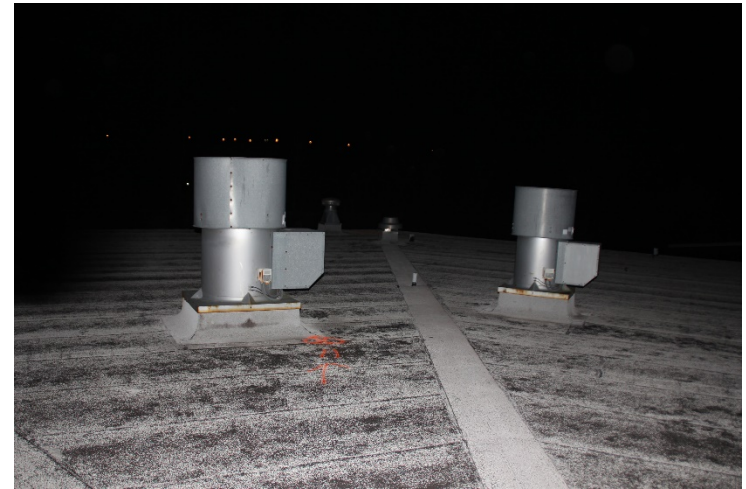
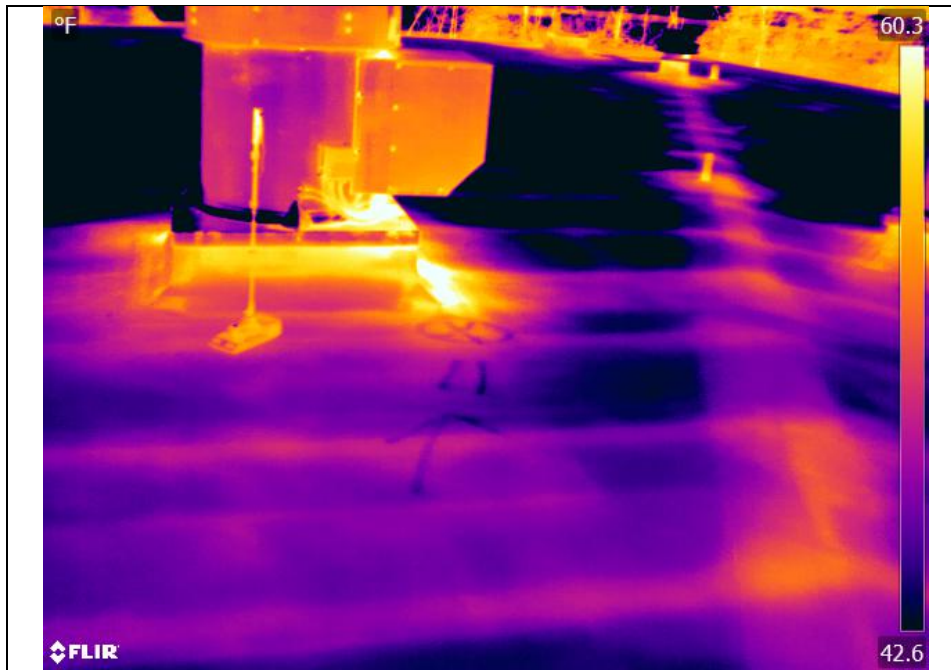
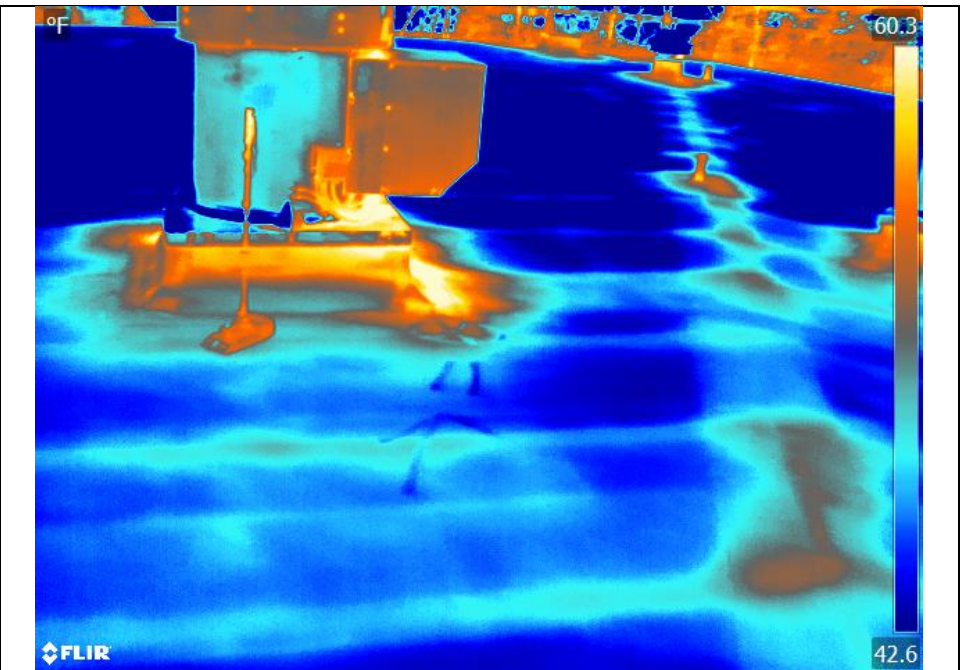
No. 11.	Job No. 20210210JCBCC	Date: 02/24/2021	Image Times: 7:50 PM – 9:18 PM
Location: Main Roof	Ambient Temp: 58 °F	Damage Type: Suspect Moisture	
Area Description:		Moisture Test Results: N/A	
Overall Size:	N/A	Moisture Probe	N/A
Previously Patched:	N/A	Core Sample:	N/A
Blisters Present:	No	Other:	Moisture Meter Positive
Comments:

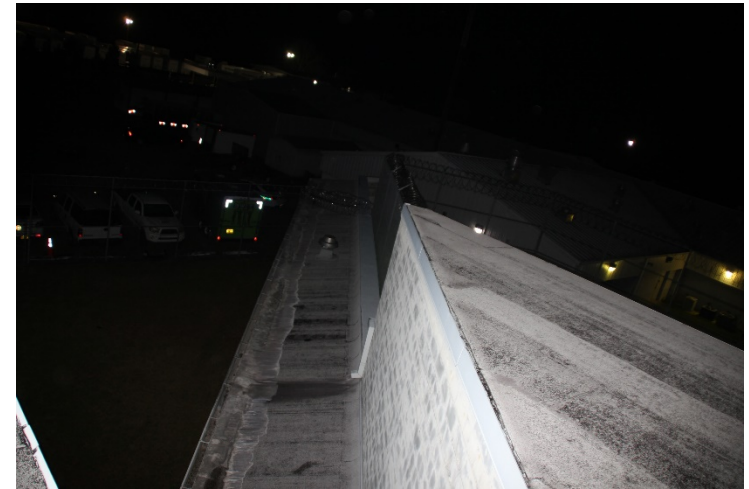
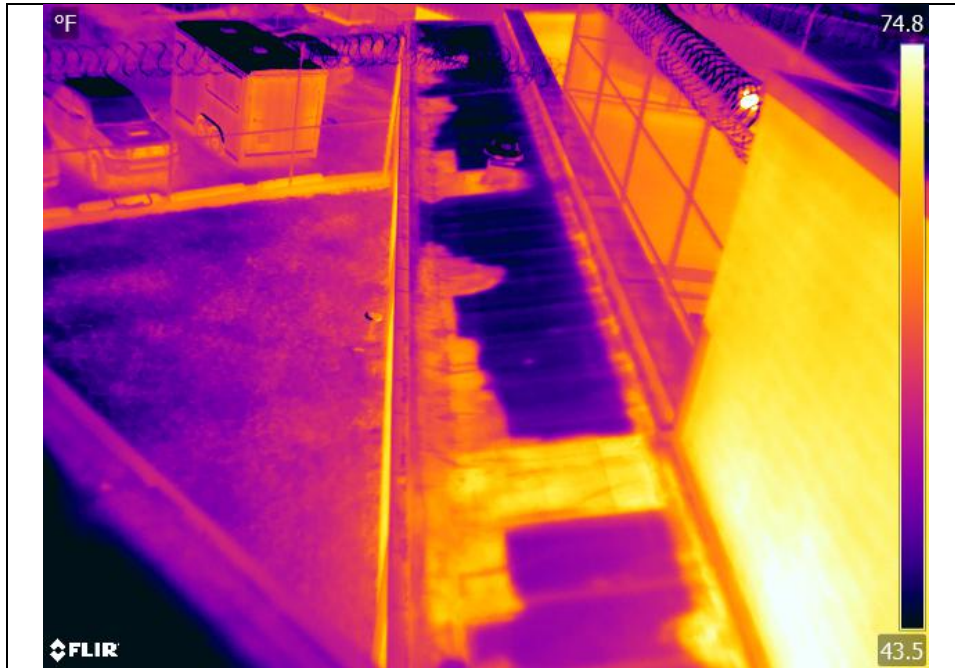
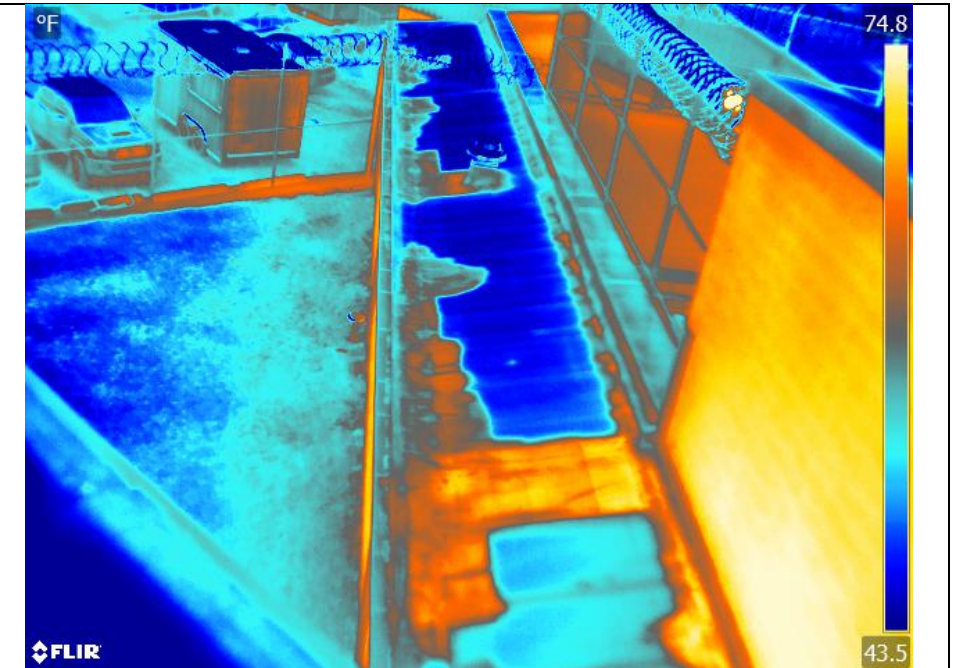
No. 12.	Job No. 20210210JCBCC	Date: 02/24/2021	Image Times: 7:50 PM – 9:18 PM
Location: Lower Roof	Ambient Temp: 58 °F	Damage Type: Suspect Moisture	
Area Description:		Moisture Test Results: N/A	
Overall Size:	N/A	Moisture Probe	N/A
Previously Patched:	N/A	Core Sample:	N/A
Blisters Present:	No	Other:	Moisture Meter: N/A
Comments:	Unable to verify thermal anomalies with the moisture meter.

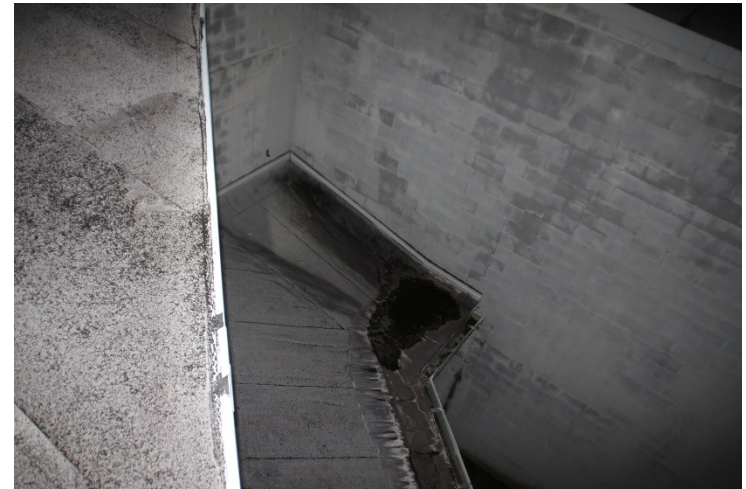
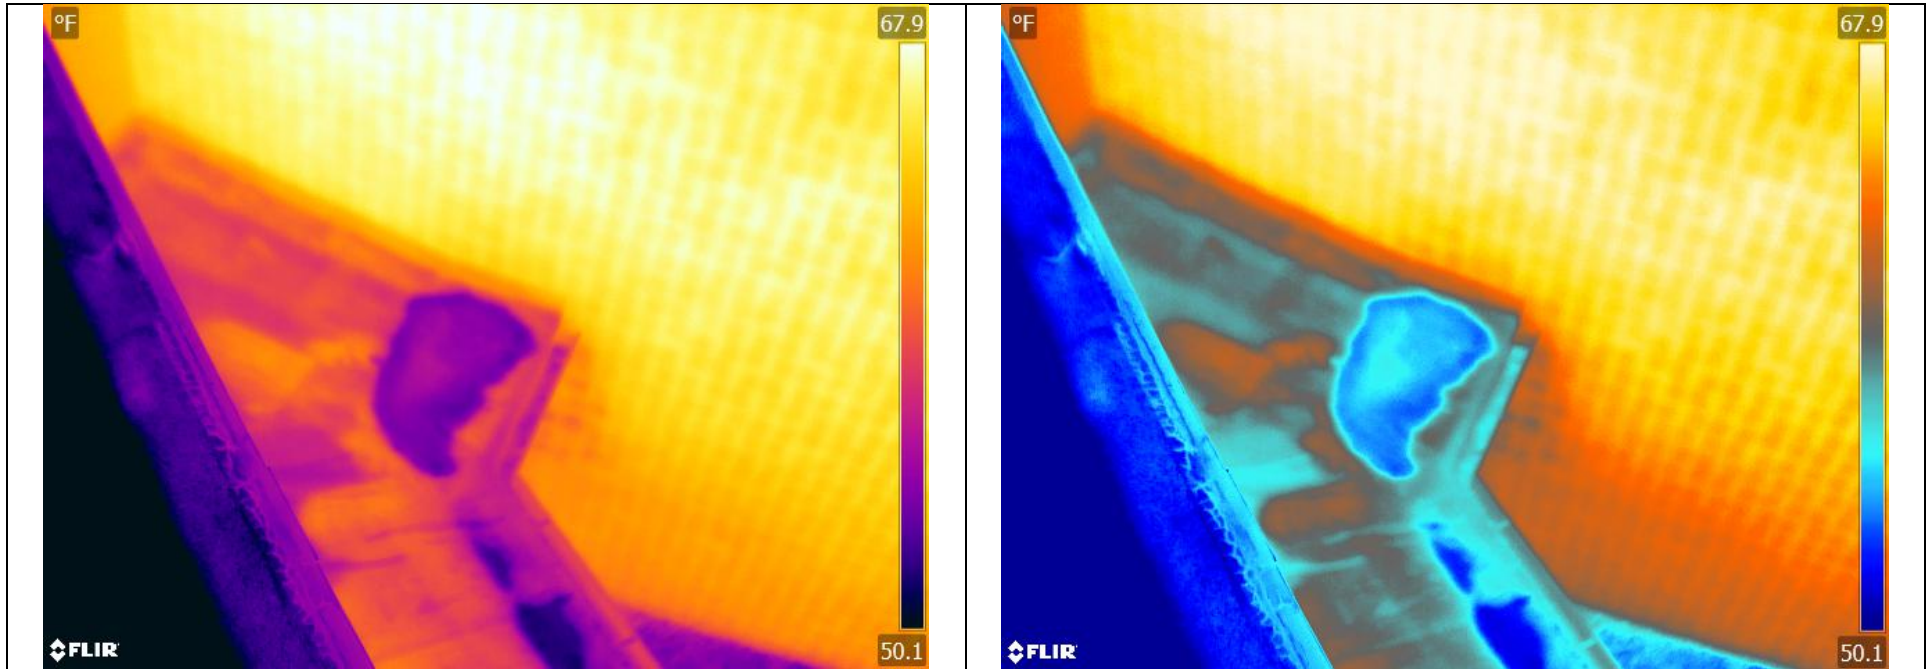
No. 13.	Job No. 20210210JCBC	Date: 02/24/2021	Image Times: 7:50 PM – 9:18 PM
Location: Lower Roof	Ambient Temp: 58 °F	Damage Type: Suspect Moisture	
Area Description:		Moisture Test Results: N/A	
Overall Size:	N/A	Moisture Probe	N/A
Previously Patched:	N/A	Core Sample:	N/A
Blisters Present:	No	Other:	Moisture Meter: N/A
Comments:	Unable to verify thermal anomalies with the moisture meter.
