Infrared Inspection Report Roof System

Jefferson County Jail

Report Date: February 26, 2021

Job Number: 20210210JCBCC

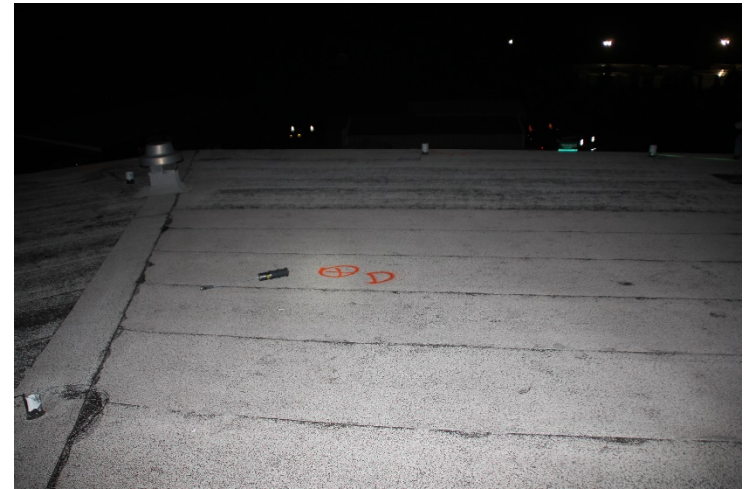
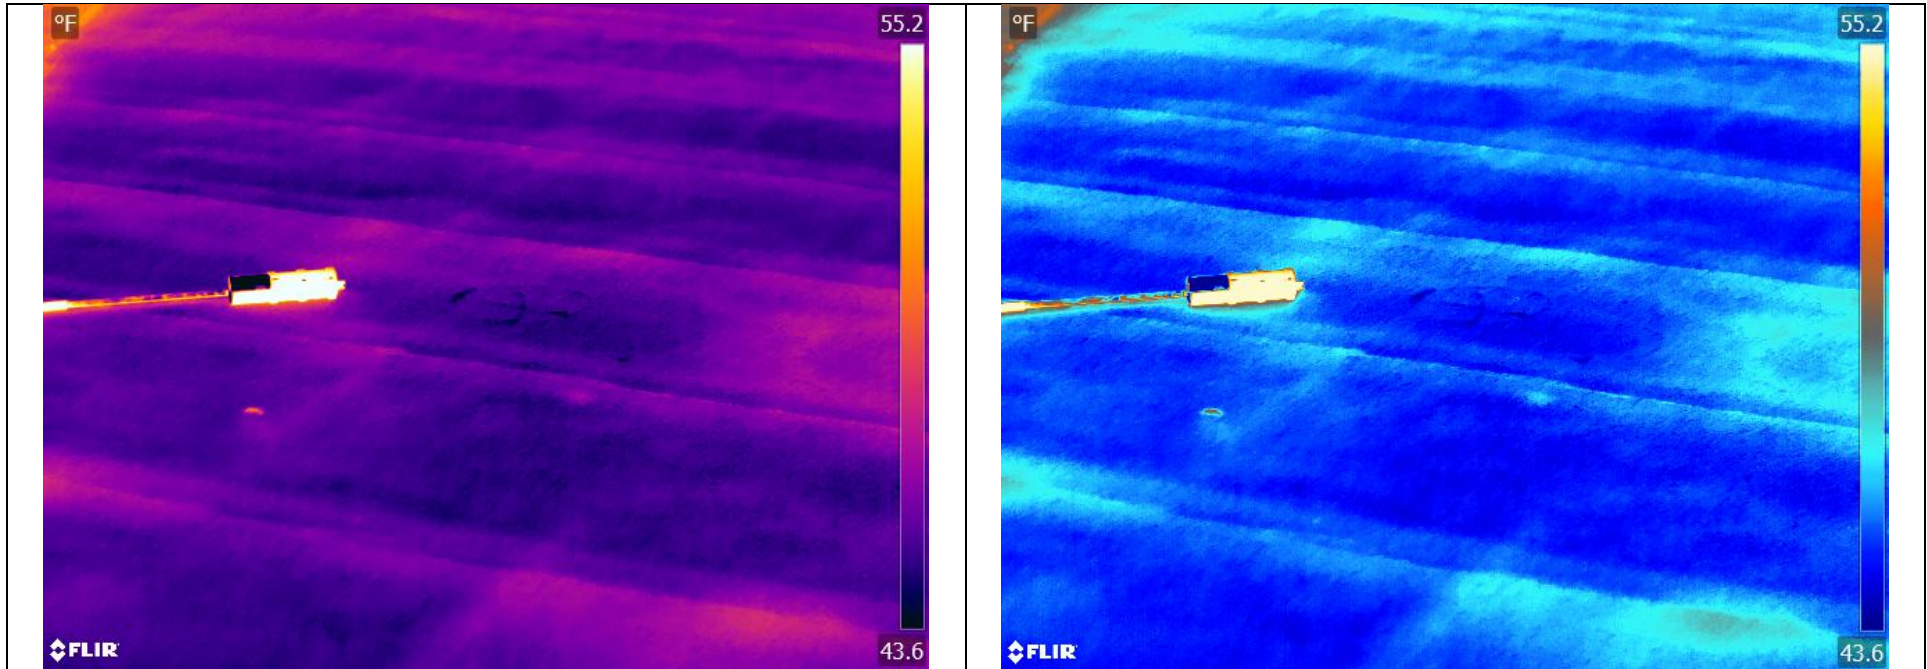
No. 14.	Job No. 20210210JCBCC	Date: 02/24/2021	Image Times: 7:50 PM – 9:18 PM
Location: Main Roof	Ambient Temp: 58 °F	Damage Type: Suspect Moisture	
Area Description:		Moisture Test Results: 5.8 - GREEN	
Overall Size:	N/A	Moisture Probe	N/A
Previously Patched:	N/A	Core Sample:	N/A
Blisters Present:	No	Other:	Moisture Meter: N/A
Comments:	The core was dry to the touch.
