Infrared Inspection Report Roof System

Jefferson County Jail

Report Date: February 26, 2021

Job Number: 20210210JCBCC

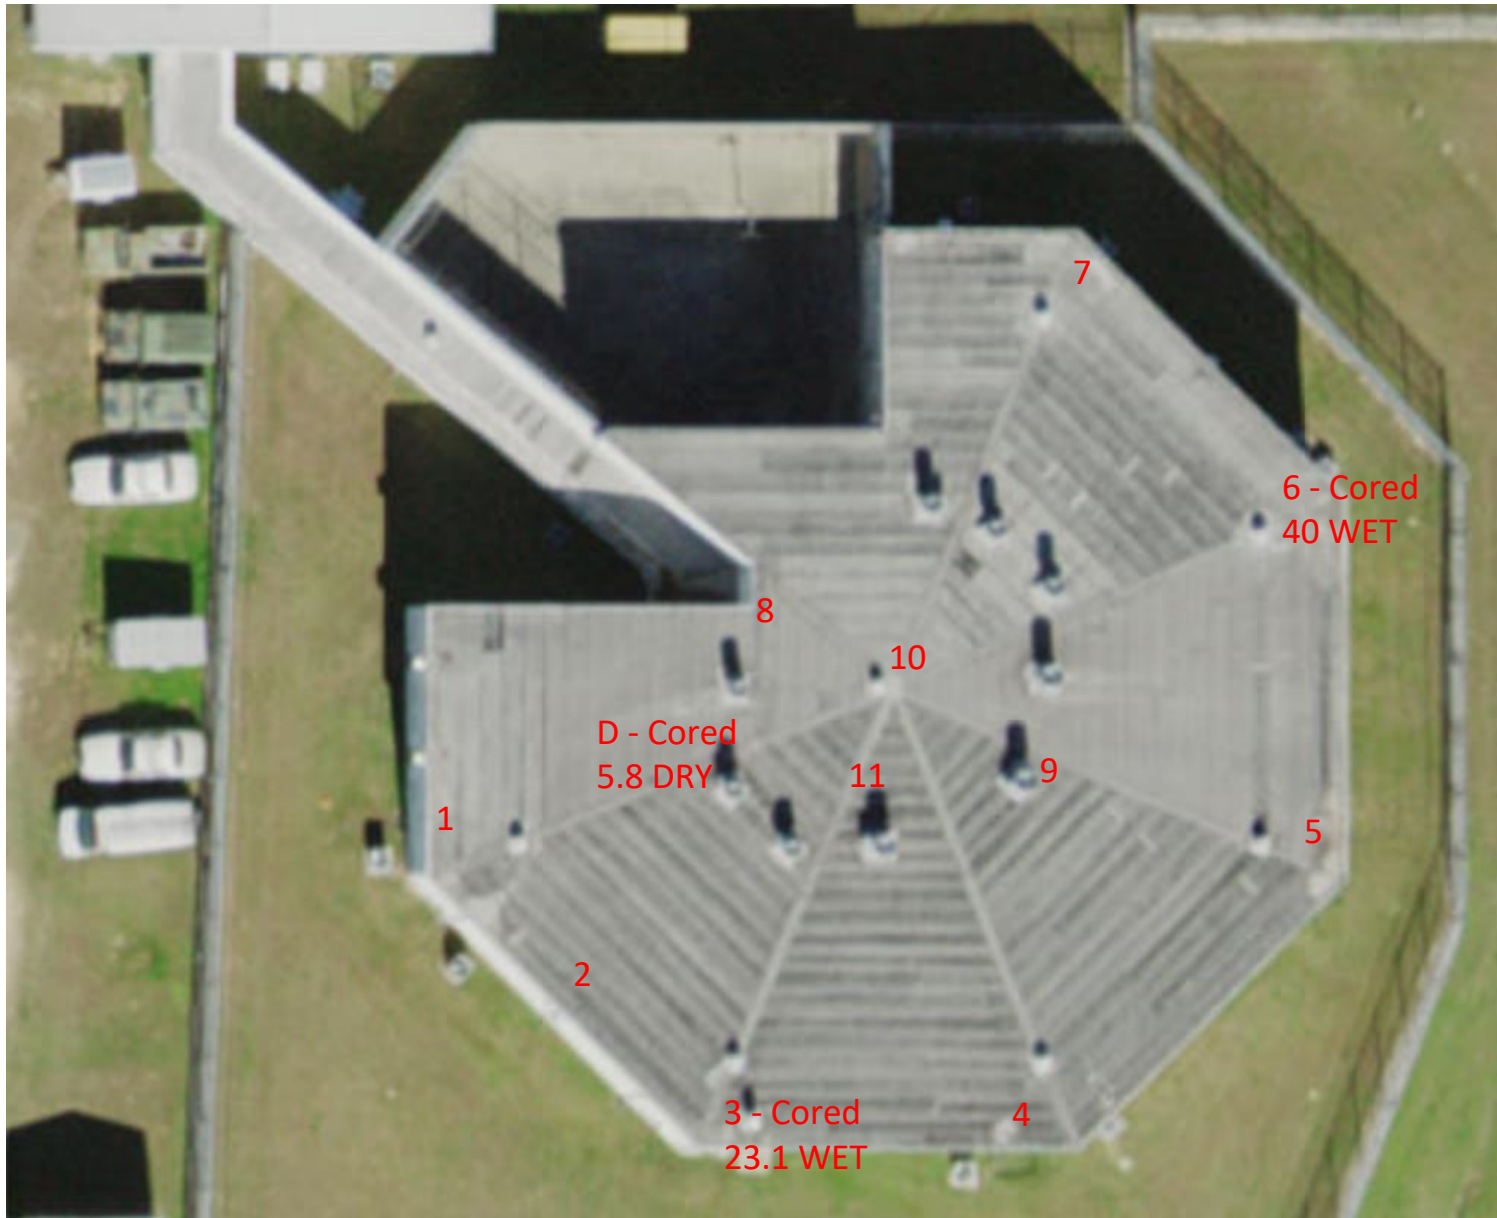
INFRARED LOCATIONS

Designated on Roof Surface:	Yes
Core Sample Size:	2"
Core Sample Taken By:	Mark Weller – Weller Infrared Services, Inc.
Moisture Present:	#2 & #3 – See location and results on the image page.
Date Taken:	February 24, 2021
